NBSIR 81-2394(R)

Metallurgical Evaluation of Seamless Stainless Steel Cylinder

Final Report

John H. Smith

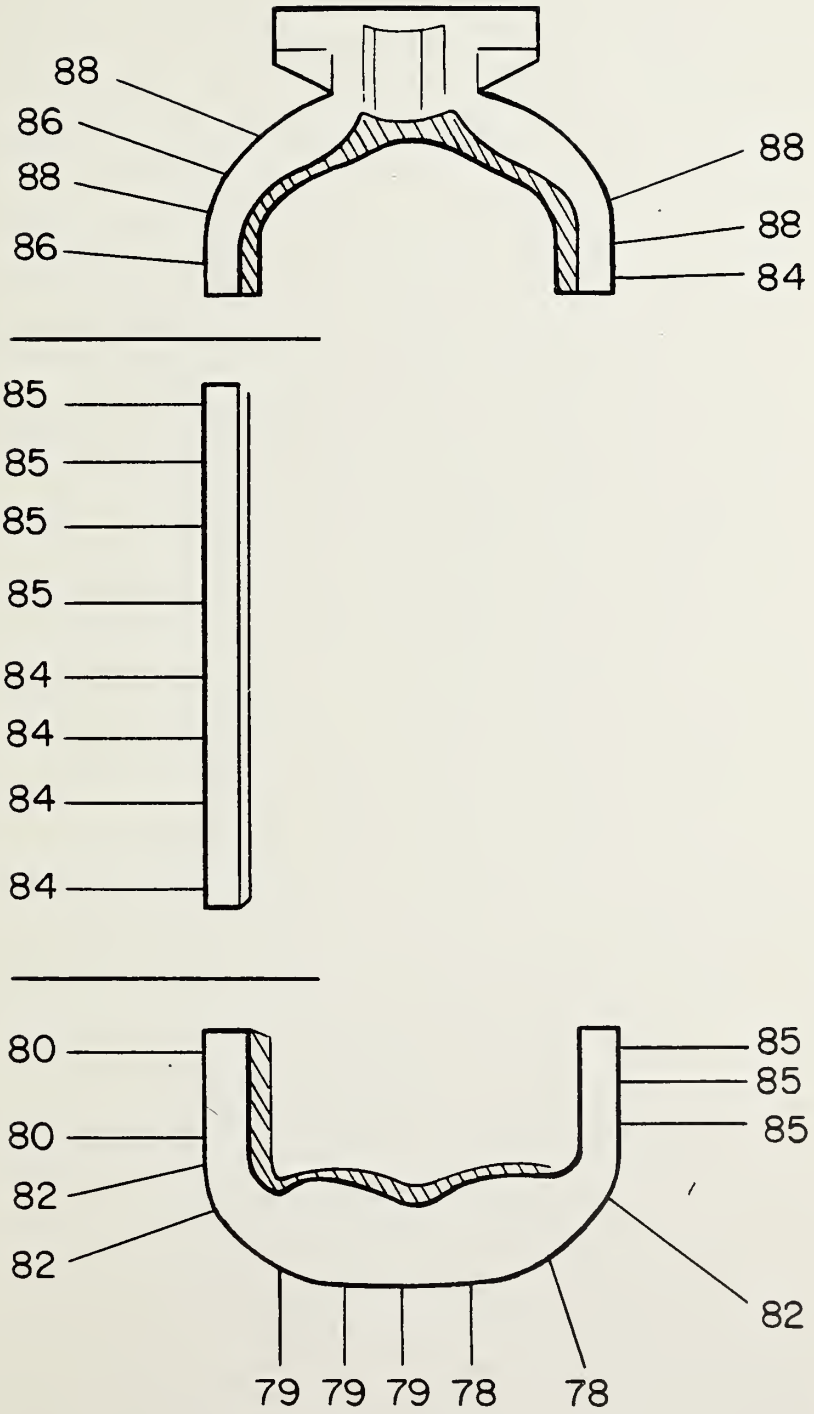
Fig. 1. Sections of Cylinder As Received.

Sections of a seamless cylinder from a lot of 12 cylinders manufactured by Autospin Inc., Carson, California were supplied by the Department of Transportation (DOT) to NBS for metallurgical and mechanical properties evaluation. The cylinders in the lot were 2.000-inches (5.080 cm) outside diameter, 16.250-inches (41.275 cm) long and had a minimum wall thickness of 0.183-inch (0.465 cm). The cylinders were made from seamless tubing of type 304 stainless steel (ASTM designation A511) and were made to comply with the DOT specification No. DOT-3A-500 (49 CFR part 178.36). The cylinders were manufactured by hot spinning the ends on sections of annealed, seamless, stainless steel tubing. The hot spinning was reported to have been done at a temperature of 1600°F (871°C) and was followed by water quenching.

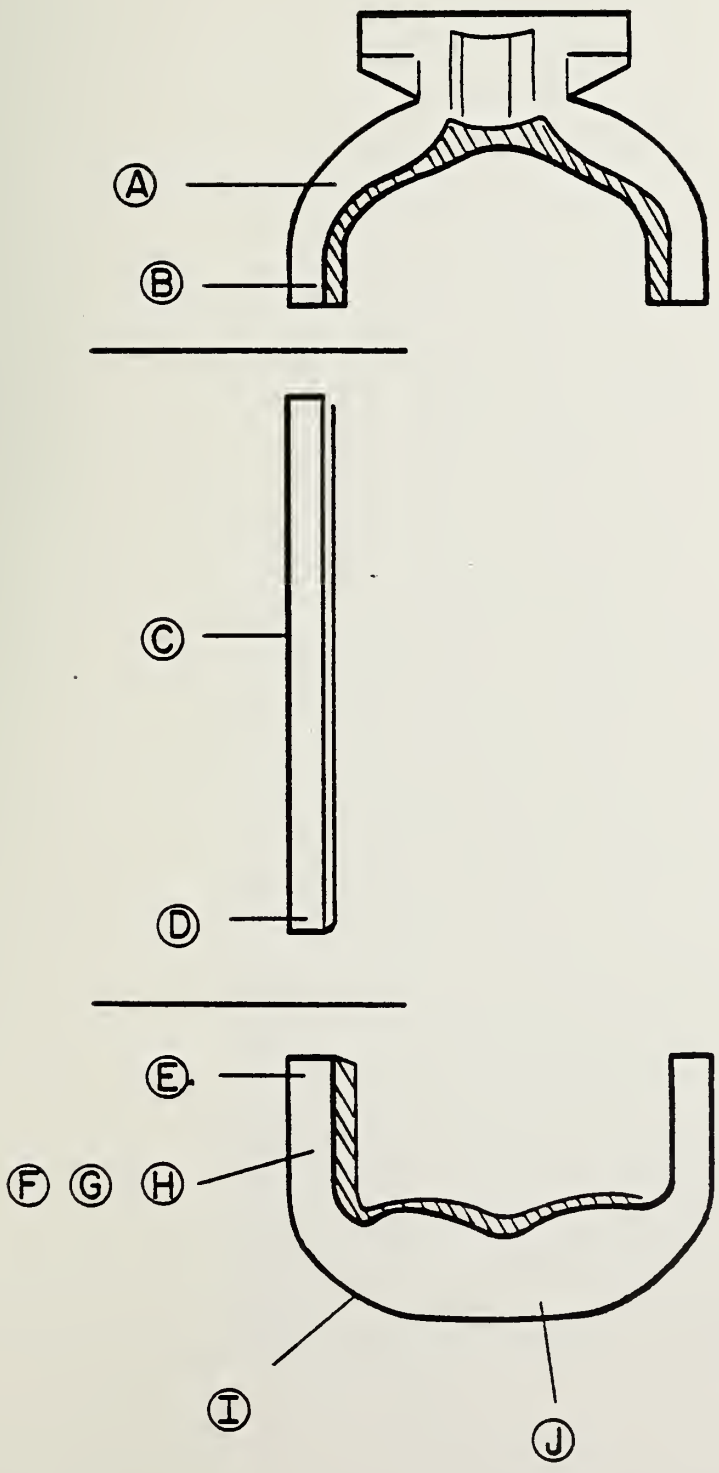
FIG. 2 HARDNESS MEASUREMENTS (ROCKWELL B SCALE)

To evaluate the uniformity of the completed cylinder, the cylinder was sectioned longitudinally and hardness measurements were made on the neck, sidewall, and bottom of the cylinder. The hardness results are shown in Figure 2. These results show that the hardness is quite uniform throughout the cylinder and is typical of that of annealed stainless steel of type 304. The hardness of annealed 304 stainless is specified to be in the range of 75 to 90 on the Rockwell B scale (2) variation from a hardness of 88 R_B at the cylinder neck to a hardness of 84 R_B along the cylinder sidewall were observed. This range of hardness is within the normally expected variation for a uniform wrought stainless steel product and indicates that the cylinder was essentially annealed with only a very minimum amount of cold work during fabrication of the cylinder. The bottom of the cylinder, which was hot spun and water quenched, exhibited hardness levels of 78 R_B to 85 R_B. These hardness levels are slightly below the hardness levels found in the sidewall and neck of the cylinder. This indicates that some slight softening due to annealing and possibly grain coarsening occurred during the hot spinning of the cylinder bottom. For comparison, a sample was cut from the sidewall of the cylinder, fully annealed for 1 hour at 2000°F (1093°C) and water quenched. This fully annealed sample had hardness measured in the range 73 R_B to 77 R_B. This indicates that the bottom of the cylinder, which had a hardness of 78 R_B to 82 R_B, was essentially fully annealed.

Overall, the hardness measurements, which ranged from 78 R_B to 88 R_B throughout the completed cylinder, indicate that the properties of the metal in the cylinder are only slightly more variable than would be expected if the cylinders were fully heat treated by annealing after completion of the fabrication of the cylinder. As indicated by the fully annealed test sample, further annealing might lower the hardness even further to the 73 R_B to 77 R_B range due to grain coarsening.

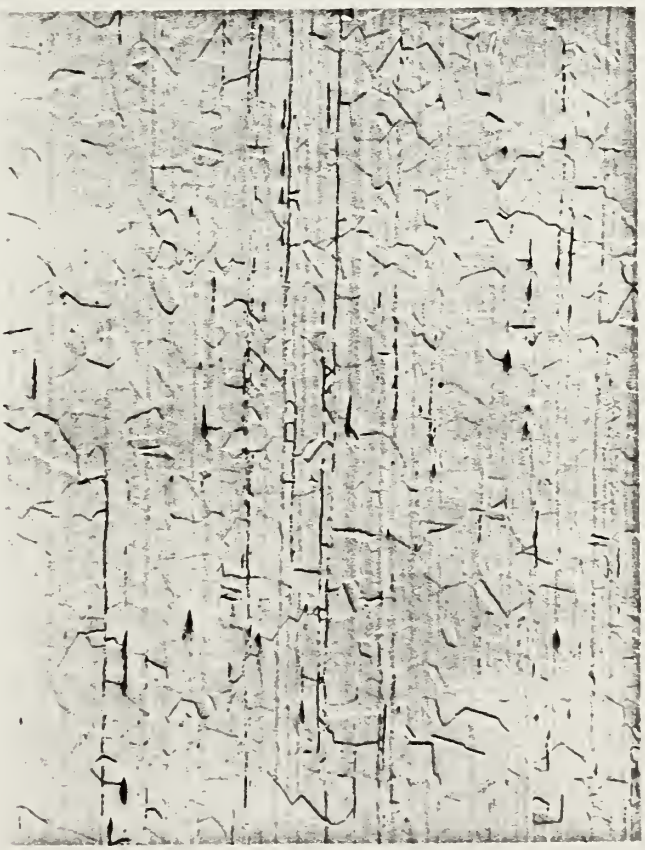
The microstructure shows a slight amount of cold work at the neck of the cylinder as indicated by slightly distorted and elongated grains (Figure 4 and 5, Photomicrographs A and B). The remainder of the cylinder has a microstructure that is primarily equiaxed grains typical of annealed stainless steel (Fig. 6, 7, 8, 9, 10, 11, 12, 13 corresponding to locations C, D, E, F, G, H, I, J of Fig. 3). The microstructure at the bottom of the cylinder (Fig. 12 and 13), which was formed by hot spinning, shows somewhat larger equiaxed grains than the rest of the cylinder which indicates that some grain coarsening occurred during the hot spinning.

Fig. 4. Photomicrograph at Location A showing slightly deformed grains. Mag. 100X

Fig. 5. Photomicrograph at Location B showing slightly deformed grains. Mag. 100X

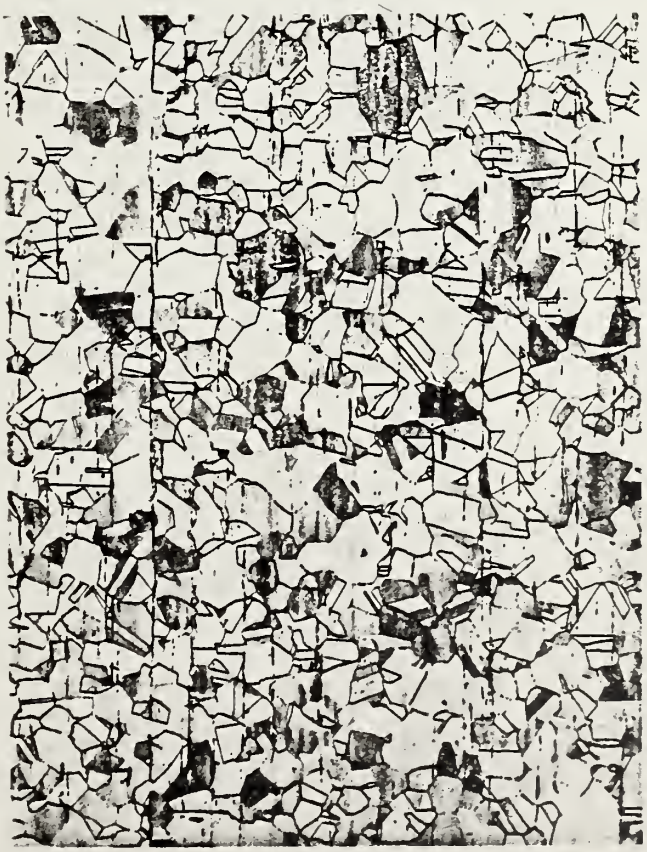
Fig. 6. Photomicrograph at Location C showing equiaxed grain structure. Mag. 100X

Fig. 7. Photomicrograph at Location D showing typical ferrite stringer. Mag. 500X

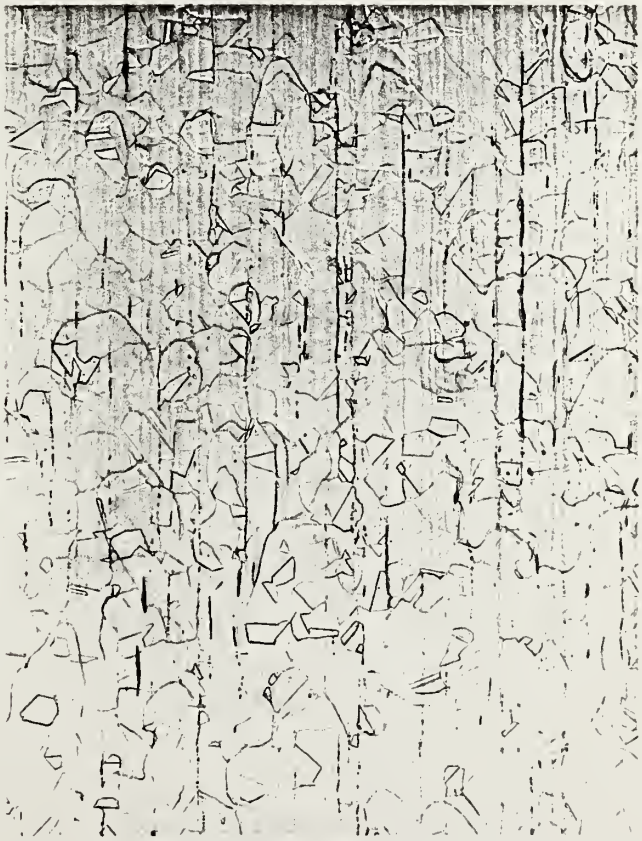
Photomicrographs taken along the sidewall of the cylinder but near the bottom (Fig. 8, 9, 10 at locations E, F, G) did show evidence of carbide precipitation at the grain boundaries. This indicates that although the bottom of the cylinder was heated sufficiently to avoid sensitization, the sides of the cylinder a short distance back from the bottom were heated by conduction into the critical temperature range to cause sensitization.

Fig. 8. Photomicrograph at Location E showing carbide precipitation at grain boundaries. Mag. 100X

However, annealing followed by water quenching would remove any carbide precipitation at the grain boundaries which leads to sensitization and can cause a significant decrease in the corrosion resistance of the cylinder. Some sensitization was observed in the sidewall of this cylinder just above the hot spun bottom. The carbide precipitation and sensitization is a reversible process and is removed by annealing of the stainless steel at temperature above 1600°F (871°C) followed by rapid cooling (water quenching). As shown by Figure 14, all traces of sensitization were removed by a proper anneal of a section of the cylinder. Therefore, if the fabrication of the cylidner causes it to be heated within the critical temperature range of 800°F (427°C) to 1600°F (871°C) where sensitization can occur, it is recommended that a final annealing of the complete cylinder be performed.

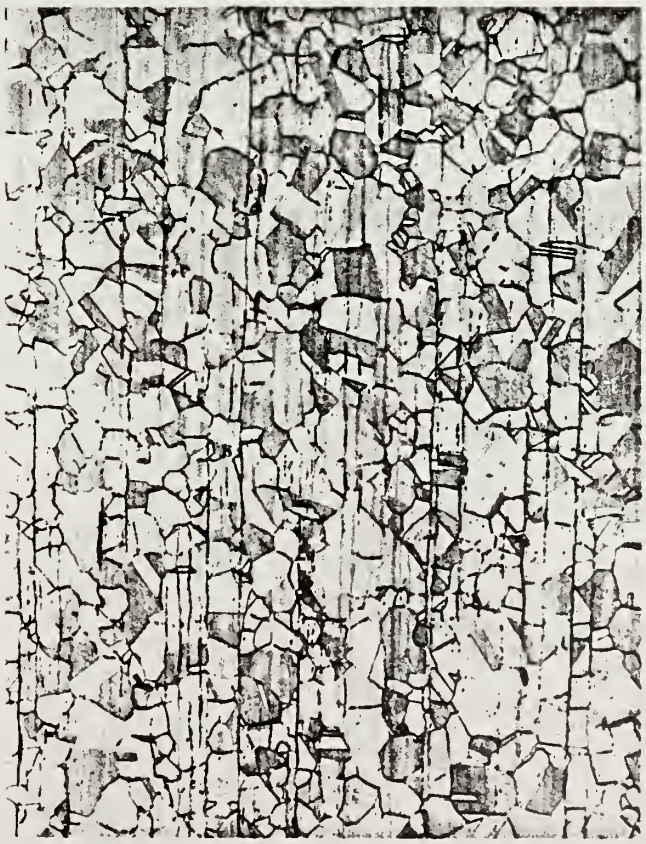
Fig. 9. Photomicrograph at Location F showing equiaxed grain structure. Mag. 100X

Fig. 10. Photomicrograph at Location G showing carbide precipitation. Mag. 100X
